# A Review: Reliability Assessment of Isolated Phase Busduct Through FMEA and RCFA Methodologies

Handoko Rusiana Iskandar, Ahmad Daelami, Awang Rahmawan Prakoso, Cepi Arifin, and Miftah Farid

Electrical Engineering Department, Faculty of Engineering, Universitas jendral Achmad Yani, Cimahi, Indonesia. <u>handoko.rusiana@lecture.unjani.ac.id</u>, <u>ahmad.daelami@lecture.unjani.ac.id</u>, <u>awangprakoso@gmail.com</u>, <u>cepiarifin6@gmail.com</u>, <u>miftahfa@gmail.com</u>

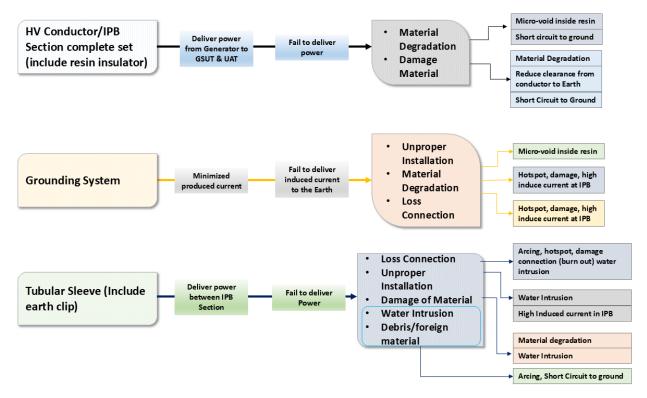
Figure 2. Isolated Phase Busduct using FMEA

The figure 2 shows the FMEA for the IPB system, focusing on potential failure modes across three major components: the HV Conductor/IPB Section (including resin insulator), Grounding, and the Tubular Sleeve (including earth clip). It illustrates the systematic approach for identifying and mitigating failure risks based on operational flow, material degradation, and installation errors. The initial element of the flowchart analyses the HV Conductor/IPB section, encompassing resin insulation, and its essential function in transmitting power from the generator to the Grounding Switch Unit (GSU) and Unit Auxiliary Transformer (UAT). The procedure commences by evaluating material degradation, which may lead to substantial failure. The existence of tiny voids inside the resin, which causes a short circuit to ground, is a major contributor to material deterioration in this context. The consequences of such deterioration may cause harm to the materials used, reducing their insulating properties and overall system performance. The following failure mechanism involves material deterioration, which is often caused by reduced clearance between conductors and the Earth, resulting in a short circuit to ground. If these mistakes are not addressed promptly, they can cause significant system instability and downtime. Effective maintenance and monitoring are critical for recognizing material degradation and preventing breakdowns from becoming more severe.

The second critical feature of the flowchart is grounding, namely its function in decreasing induced currents and permitting the safe dissipation of current to the Earth. When the device fails to send the generated power to Earth, a variety of problems might develop. Inadequate installation of grounding components can lead to material degradation, increased risk of disconnection, and improper grounding connections, resulting in inefficient power transmission. The failure modes underscore the need of proper grounding installation in ensuring the system's dependability. Potential difficulties, such as water penetration and higher induced currents in the IPB, exacerbate the damage. Correcting the placement of grounding systems can significantly lessen these hazards. The final component focuses on the tubular sleeve, which is necessary for transporting power between IPB segments. Failures in this context include disconnections and faulty installations. Inadequate installation or degraded components impair the system's integrity, cause water penetration, and allow unwanted debris to enter the system, reducing its dependability and performance

significantly. Water penetration is acknowledged as a key cause of failure, exacerbating other failure modes such as material degradation and short circuits.

Water ingress into the IPB section can damage the resin, ruin the insulation, and cause irreparable damage to the equipment if not promptly investigated and repaired.
